Name Of Dam: BEDFORD RESERVOIR DAM

Location: BEDFORD COUNTY, VIRGINIA

(6) **PHASE I INSPECTION REPORT**  
**NATIONAL DAM SAFETY PROGRAM**

11 FEB 1979

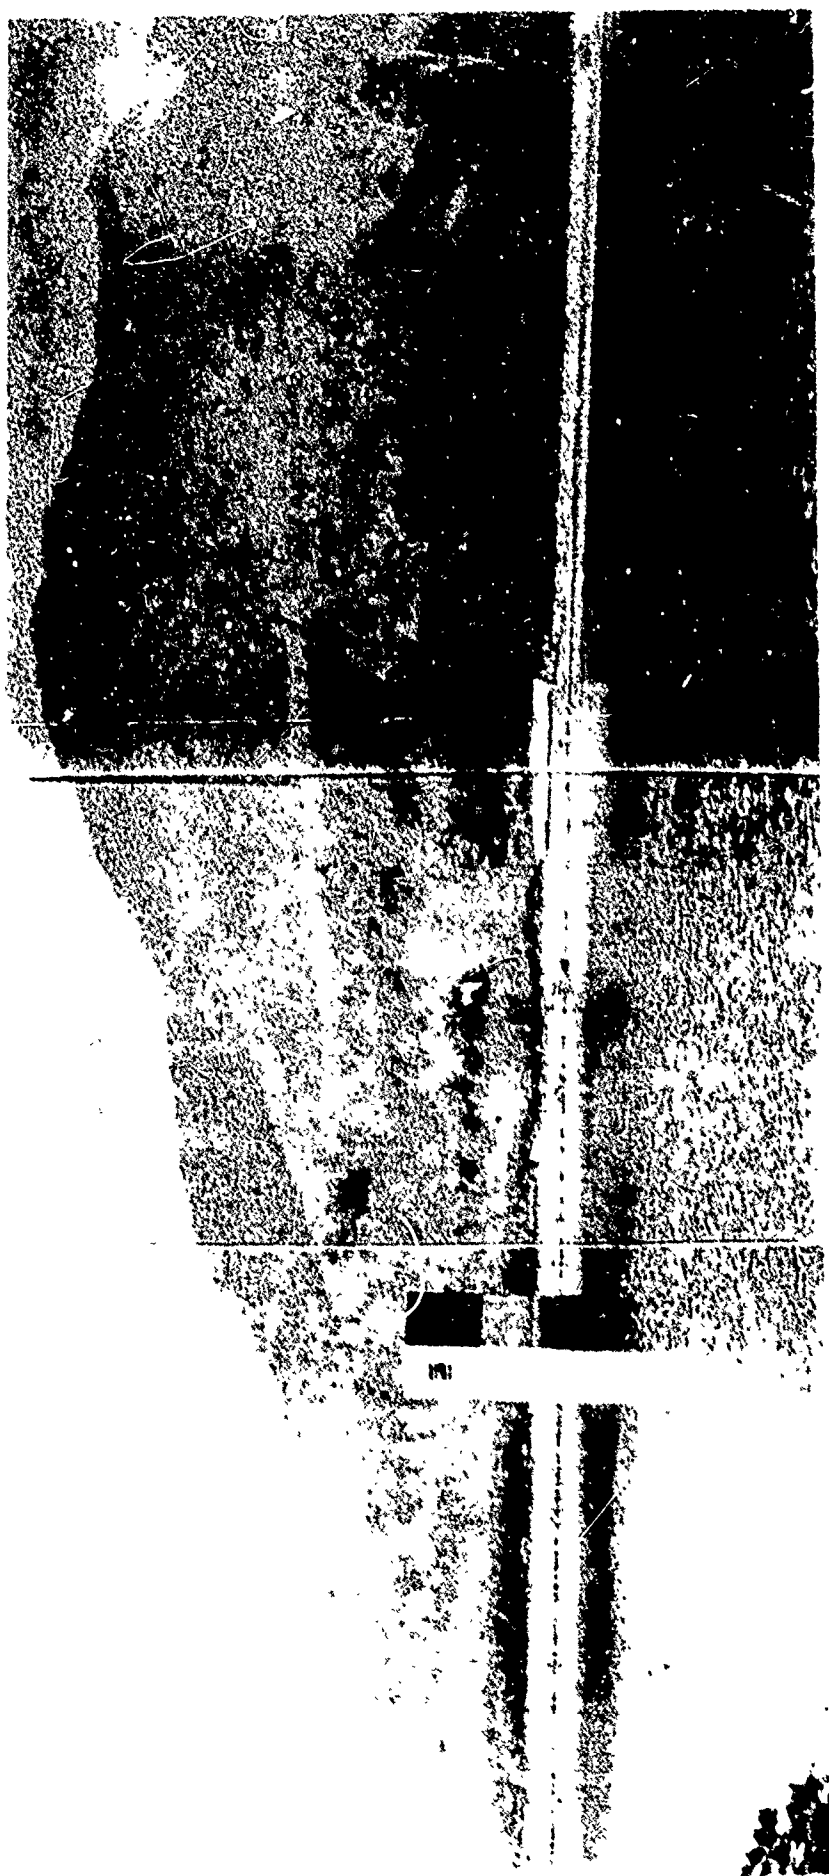
OVERVIEW OF DAM FROM RESERVOIR

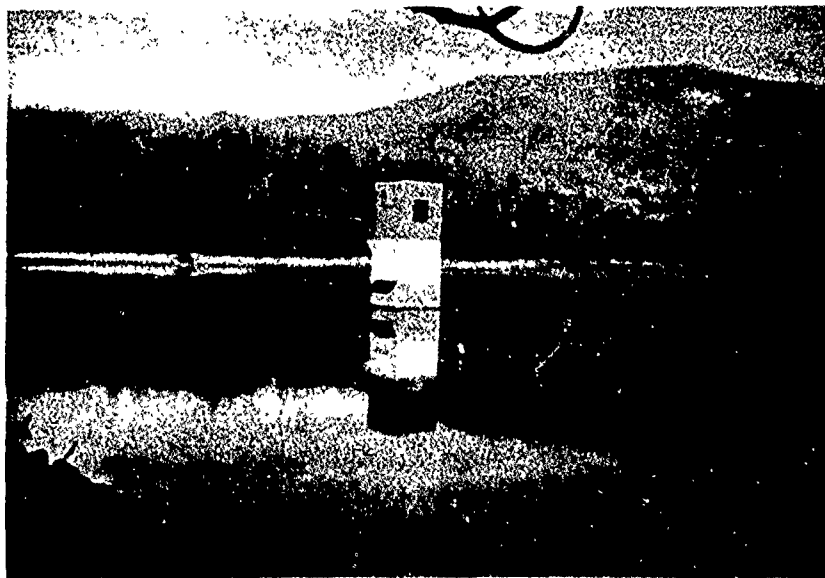
INTAKE STRUCTURE

3.1 Intake Structure: There is no access to the intake structure from the dam. The structure is concrete and showed no visible signs of deterioration. An inclosed structure sits on top the intake prohibiting observation of shafts used to operate sluice gates. No determinations of the intake structure could be made during the inspection. State Police divers found no problems during inspection in the fall of 1977.

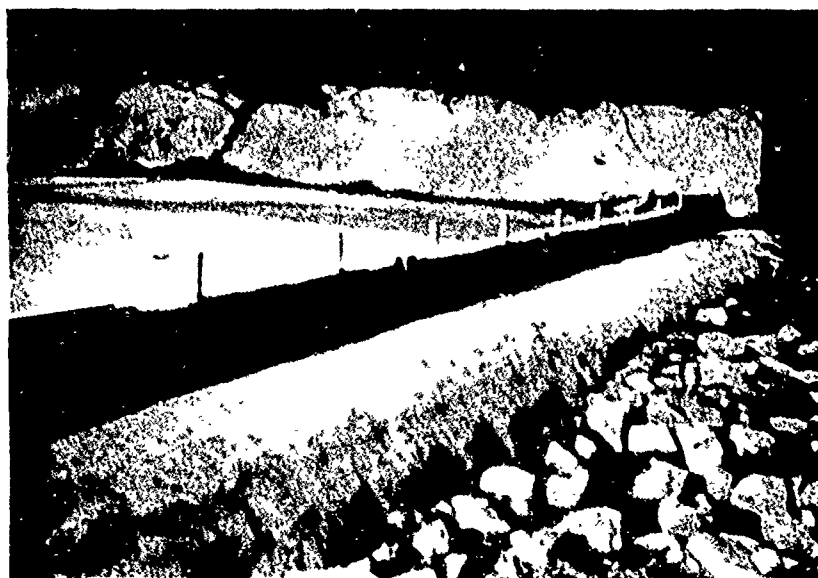
3.1.4 Emergency Spillway: The spillway is in good condition except for the following deficiencies: portions of the flashboards are missing near the right abutment, a tree is growing out of one joint, the riprapped discharge channel has eroded away on the left side, the right side is overgrown with vegetation, and debris has blocked the right wall subsurface drain.

CREST OF SPILLWAY-MISSING FLASHBOARDS
